**DEPARTMENT OF TRANSPORTATION**

Contract #: 04-0120F4Cty: SF/ALA Rte: 80 PM: 13.2/13.9File #: 69.28**WELDING INSPECTION REPORT****Resident Engineer:** Pursell, Gary**Address:** 333 Burma Road**City:** Oakland, CA 94607**Report No:** WIR-009149**Date Inspected:** 22-Sep-2009**Project Name:** SAS Superstructure**OSM Arrival Time:** 700**Prime Contractor:** American Bridge/Fluor Enterprises, a JV**OSM Departure Time:** 1900**Contractor:** Zhenhua Port Machinery Company, Ltd (ZPMC), Changxing Island **Location:** Shanghai, China**CWI Name:** Liu Fa Wen**CWI Present:** Yes No**Inspected CWI report:** Yes No N/A**Rod Oven in Use:** Yes No N/A**Electrode to specification:** Yes No N/A**Weld Procedures Followed:** Yes No N/A**Qualified Welders:** Yes No N/A**Verified Joint Fit-up:** Yes No N/A**Approved Drawings:** Yes No N/A**Approved WPS:** Yes No N/A**Delayed / Cancelled:** Yes No N/A**Bridge No:** 34-0006**Component:** OBG Crossbeams**Summary of Items Observed:**

**OBG CROSS BEAM CB1**

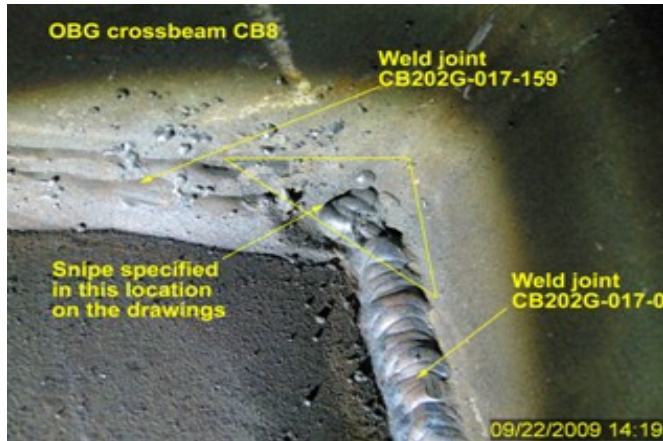
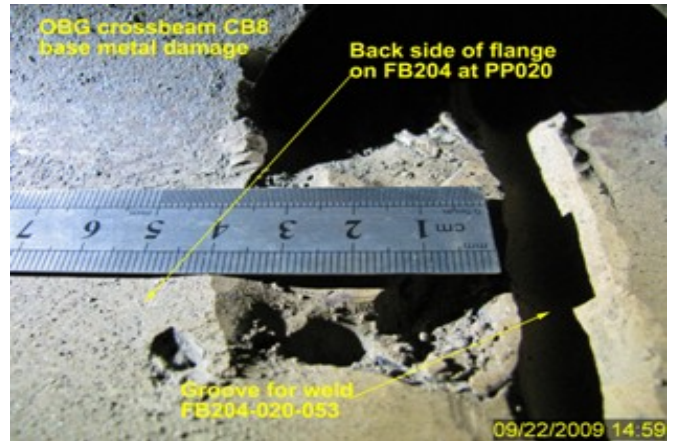
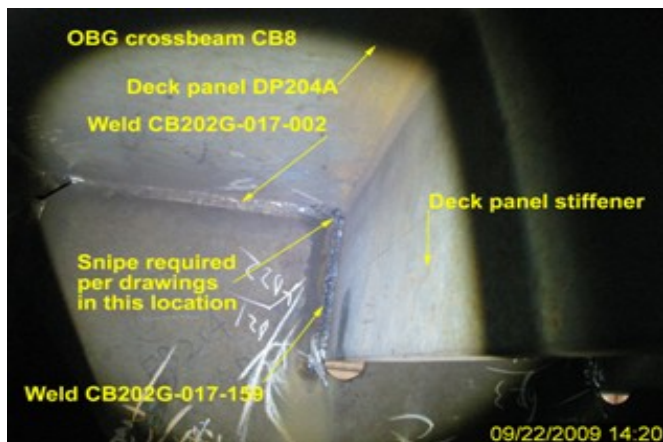
During random Visual inspection of this crossbeam this QA observed the following deficiencies:

1. Base metal gouge approximately 5mm deep near weld identified as FB204-020-053.
2. Snipe hole welded over at the intersection of welds identified as CB202G-017-002 and FB202G-017-159.

This QA notified ABF inspector identified as Mr. Chang Bao Qian and ZPMC QC inspector identified as Mr. Liu Chuan Gang of the above mentioned issues. Both inspectors verified the deficiencies and marked them on the material for repair. Mr. Liu informed this QA that ZPMC would perform the repairs per the applicable approved procedures. See attached pictures.
